## Tuff Breed® Well Service Packing Trouble Shooting

## Tuff Breed® Well Service Packing (WSP) Installation Instructions

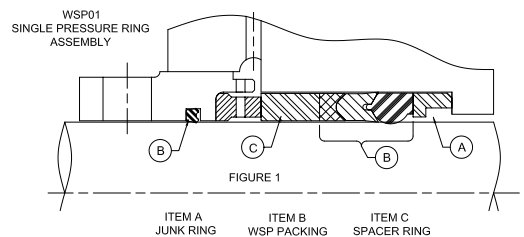
No additional adjustment is needed on High-Pressure WSP1 (single PTFE Pressure Ring & PEEK). See Figure 1.

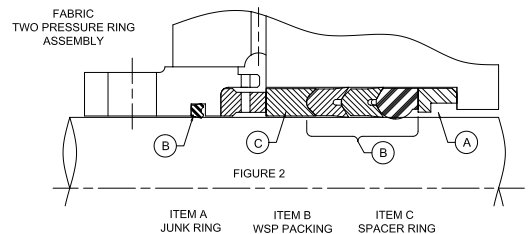
Prior to starting the pump, all fabric packing should be checked and, if loose, tightened. See Figure 2. Check packing lubricating system for satisfactory operation before each job.
